Subject: Smoky Canyon Mine Remedial Investigation/Feasibility Study
Dinwoody Material Source Investigation Report

To: Jeff Hamilton, Environmental Engineering Manager; Grant Williams, Senior Mine Engineer
From: Katie Wilkes, Geologist
Cc: Neil Musilek, Engineering Manager; Casey McCaslin, Survey
Date: November 27, 2018
Re: **Dinwoody Material Source Investigation Report**

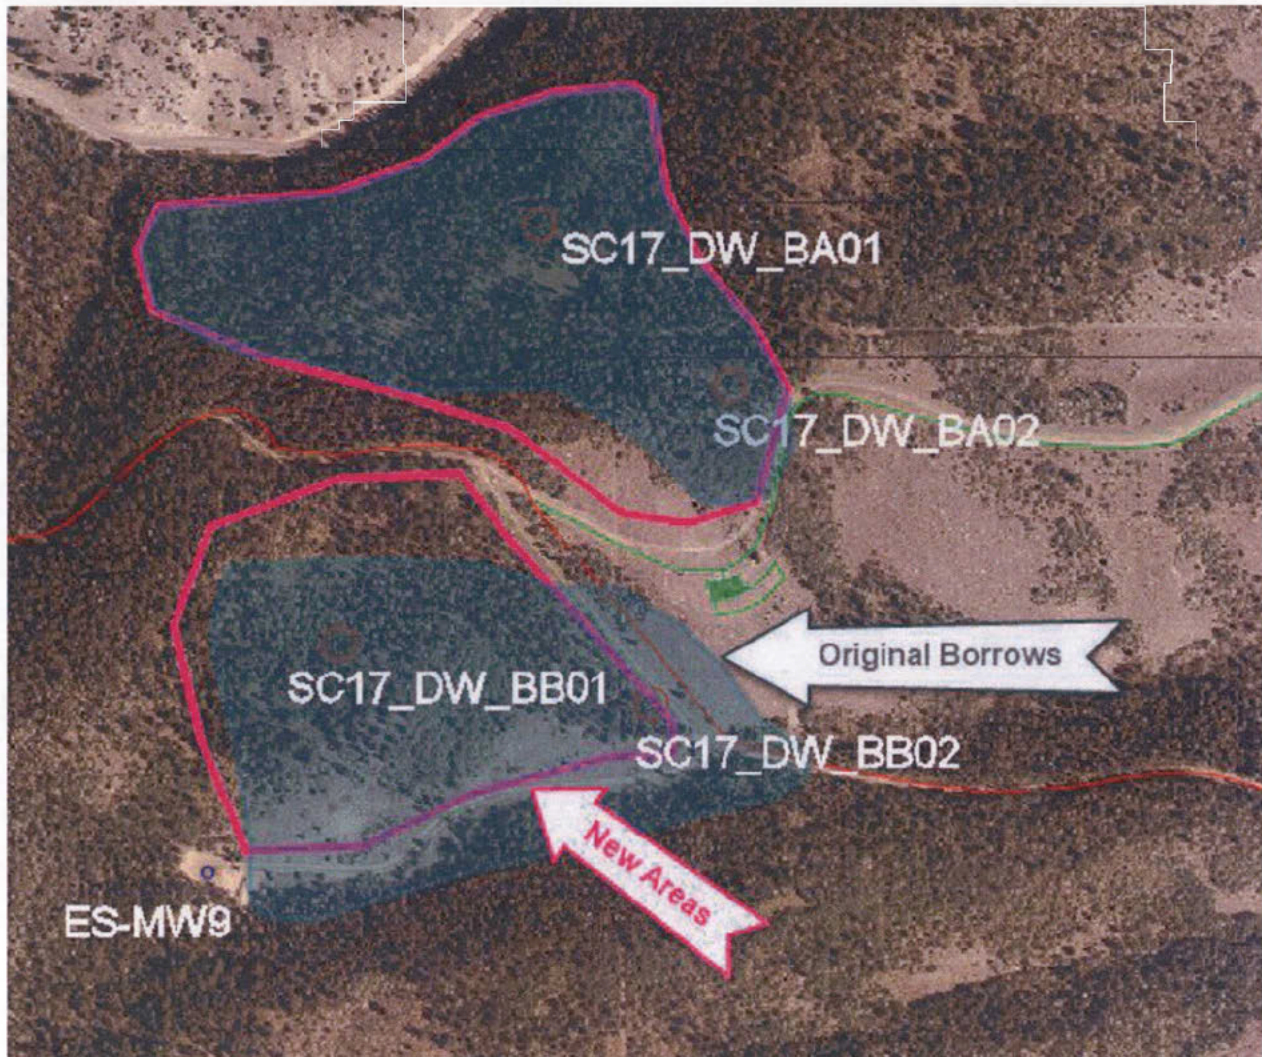
Figure 2 – B-Panel Borrow

Documentation for each excavation site and any other field observations are in the trench logs attachment. B-Panel borrow contained excellent clay rich material overall. All excavations in this area were extended to the maximum reach of the equipment. Site DW_BB02 had some less desirable gravelly zones near the surface and has been adjusted to the edge of the borrow area. **Figure 2** indicates the areas of the original B-Panel borrow designs and the new adaptations following examinations from this field program. Selected images for each site are included in this report, additional photo documentation is available within the attachments.

Volumes in this area were updated anticipating removal of 4 feet of topsoil with an overall 30 foot deep excavation below topography. Good material likely exists deeper as the termination of the excavations were in good clay material at the bottom.

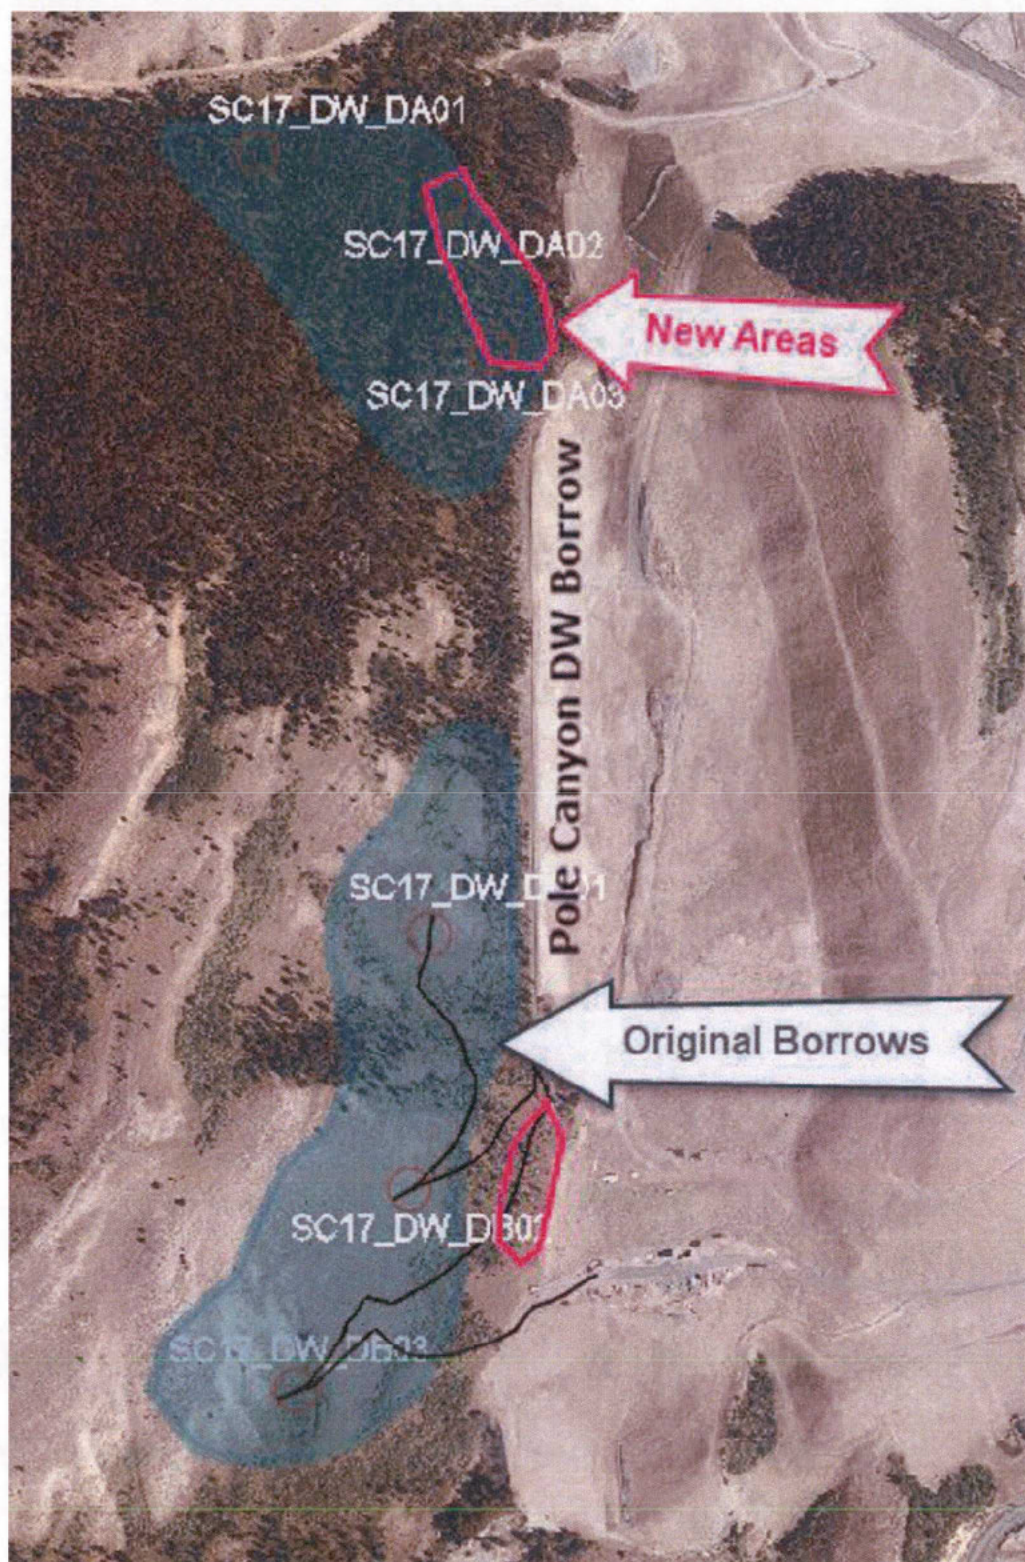
Figure 3 – D-Panel Borrow

All sites were terminated at refusal of digging and ripper teeth were broken on the rock at sites DA01 and DA03. Although none of the excavation sites indicated good quality Dinwoody cover material, road cuts were considered in evaluation of the site as a whole. Additional field notes for the D-Panel borrow areas and excavation sites are in the trench logs attachment. A general observation in the steep D and E panel areas is that there is more cliff forming rock with elevation up the slope. **Figure 3** indicates the areas of the original D-Borrow designs and the adaptations following examination from this field program. Selected images for each site are included in this report and additional photo documentation is available within the attachments.

Volumes in this area were updated within a much smaller areas. Calculations within this area assumed 3 feet of topsoil and 10 feet total depth for excavating material below topography. Despite the conservative estimate, it is still unlikely that all the area that could be excavated would be suitable for cover material.

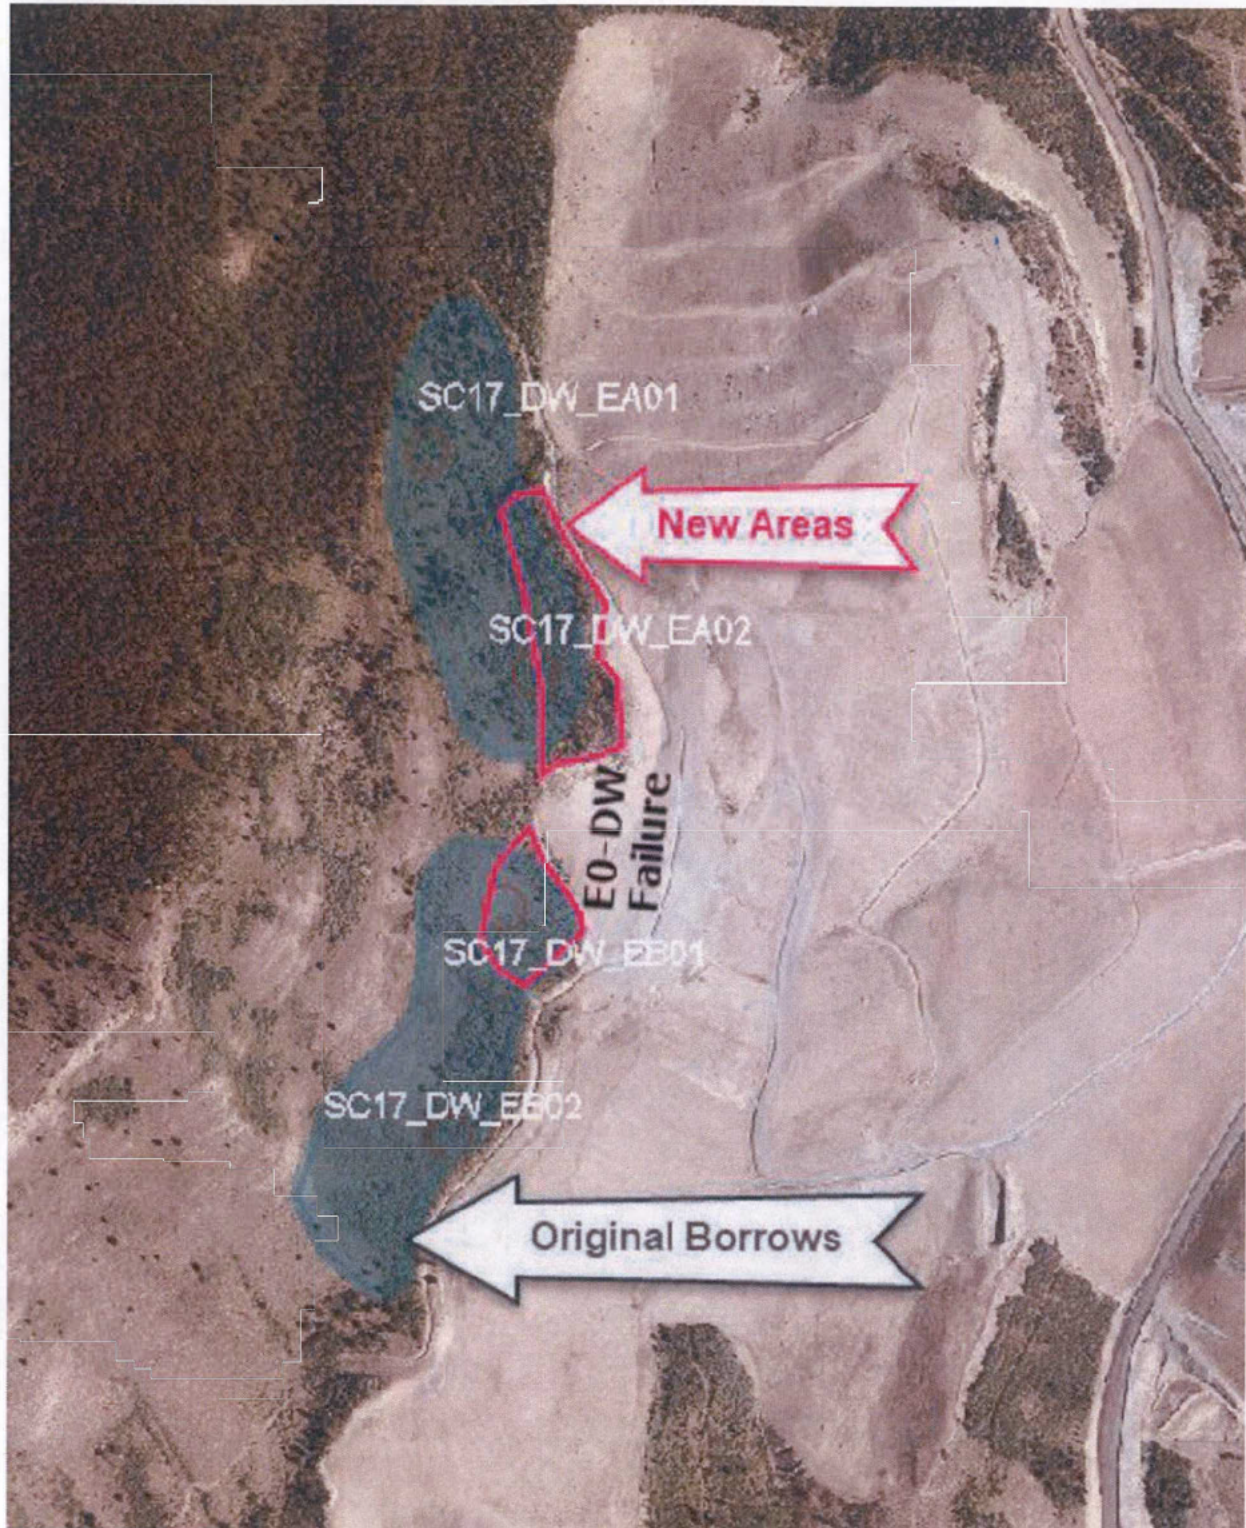
Figure 4– E-Panel Borrow

Figure 4 indicates the areas of the original E-Borrow designs and the adaptations following examinations from this field program. Selected images for each site are included in this report with additional photo documentation available within the attachments.

Volumes in this area were updated within a much smaller areas. Calculations within this area assumed 3 feet of topsoil and 15 feet total depth for excavating material below topography. Most of this material would not be suitable for cover material.

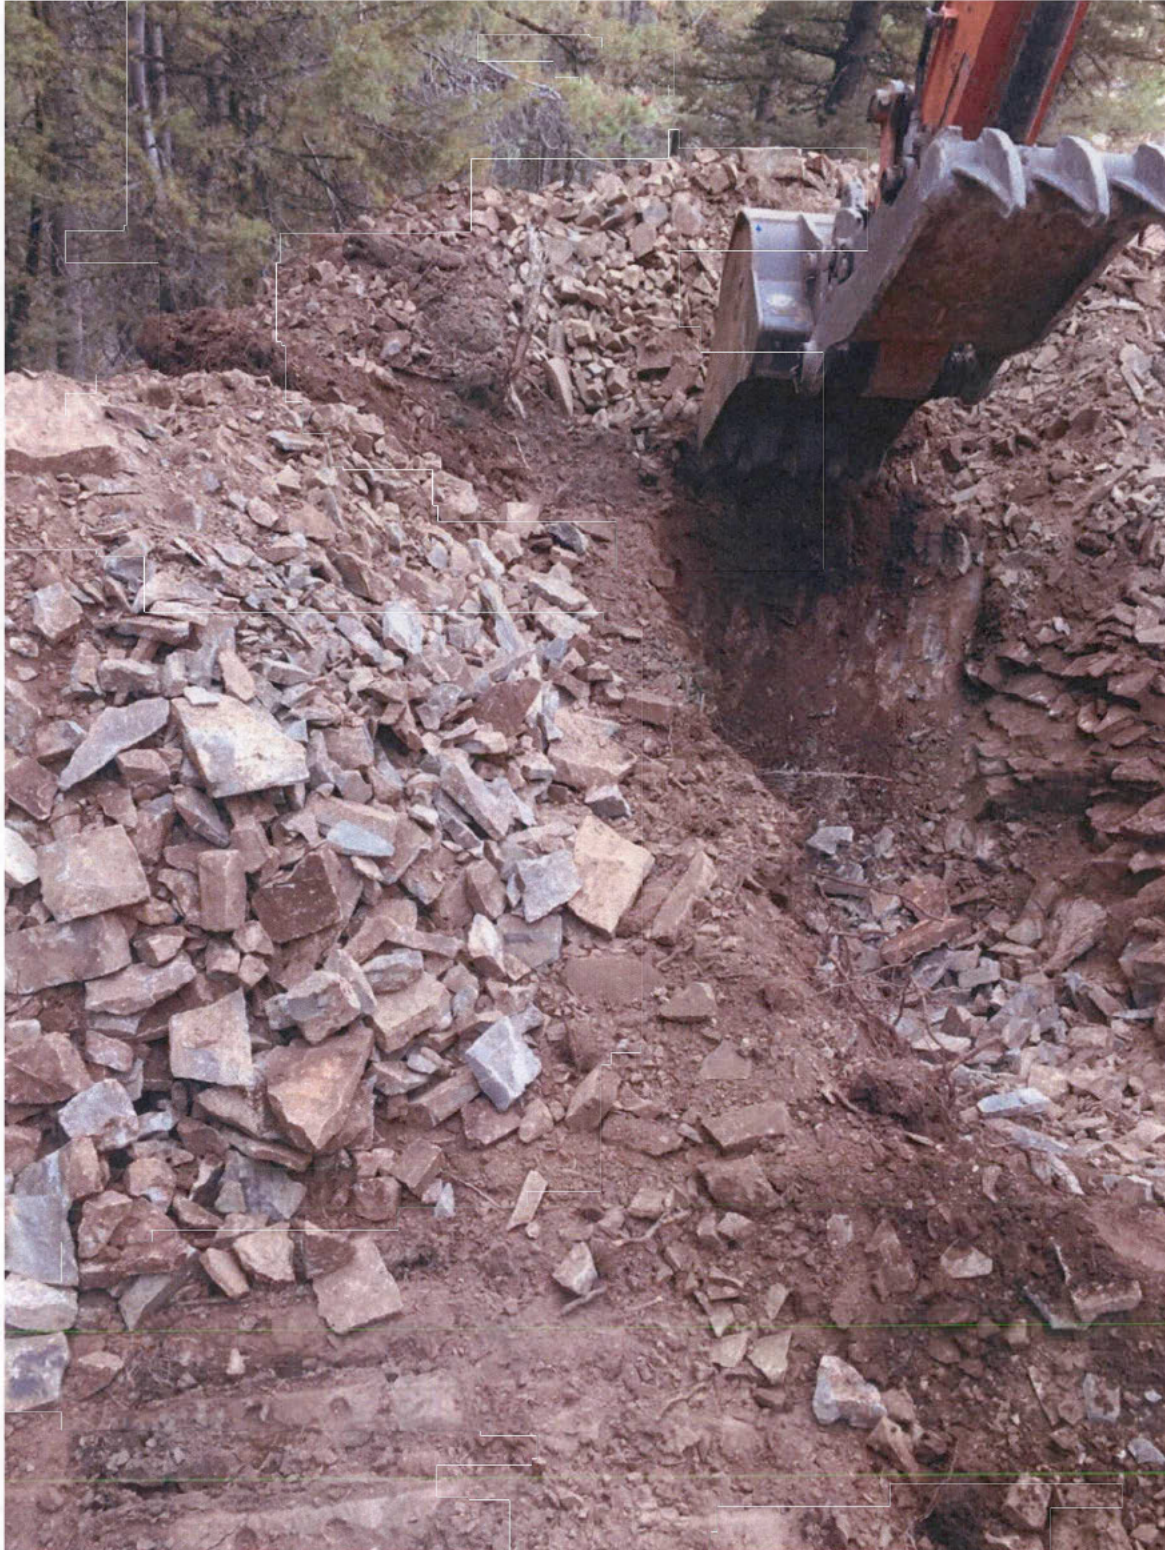
DW_EA01

All sites were terminated at refusal of digging through rock. EA01 and EB02 were completed nearly at the surface. None of the excavation sites indicated a large quantity of good cover-quality Dinwoody. Alternating rock and loose material in some locations saw better digging below the surface rock outcrops although none of the trenches were extended to the reach of the equipment before refusal. The upslope extent for accumulation of usable, weathered Dinwoody appears to coincide with the areas of existing borrows in both D and E panel. Additional field notes for the E-Panel borrow excavation sites are in the trench logs attachment.
